## INFRASTRUCTURE / DEFERRED MAINTENANCE

### *What was the situation before the renovation?*

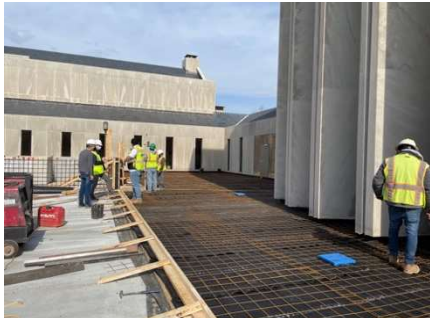
Terrace Waterproofing

- Replacement of **waterproofing system** on upper plaza and new drains
- Upgraded **Building Automation System (BAS)**, including new controller and dedicated server to capture historical records.

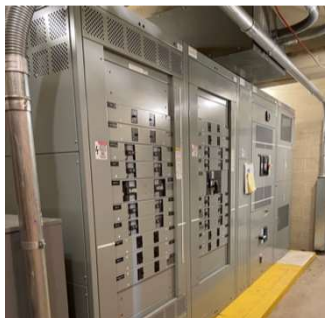
Switchgear Equipment

- **Switchgear** replacement
- Two new **boilers** and associated pipework; church now has efficient cycling between boilers
- Extensive **ductwork** and **fan coil units** in new spaces

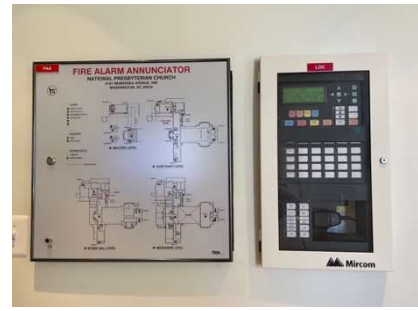
Fire Alarm System

- All new **exterior doors, hardware and security system** throughout the building
- **Fire alarm system**, including installation of strobes, speakers and smoke detectors in the Sanctuary and throughout the building

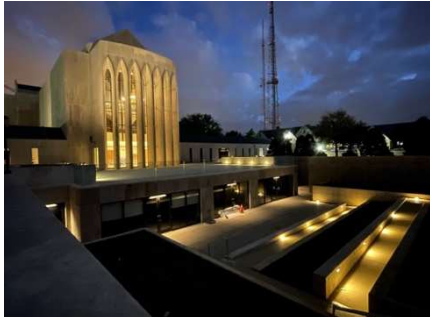
Lighting, Secure Doors & Locks

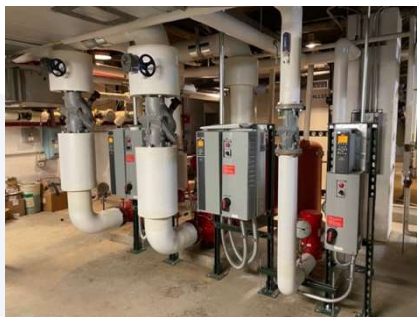
HVAC Pumps

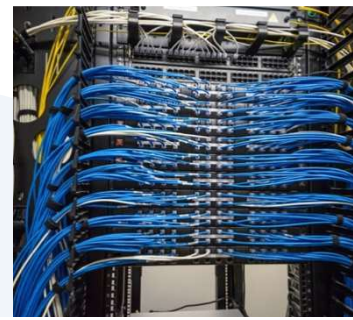
Campus-wide Fiber Loop

- Upgraded **IT system** with low voltage cable installation and campus-wide network fiber loop, providing continuous connection for all campus buildings. (See **Summary 3**)
