CENTRAL STAIRS, UPPER PLAZA, USHER CLOSET

What was here before the renovation?

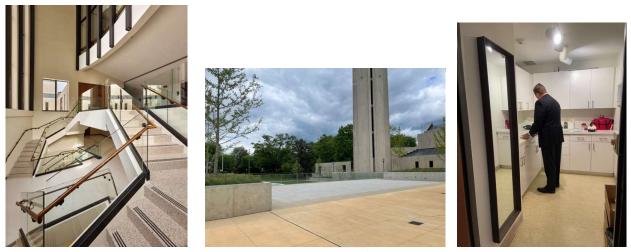
- The former stage in Stone Hall was removed and structural steel framing installed to pour a new concrete floor that connects the former north and south mezzanines. The stairs were constructed to easily access all levels and be close to our new Garden Rooms on the 2nd floor.

- The stair structure is steel with terrazzo treads to match the Sanctuary level floors. The glass guardrails of the staircase enable light to reflect and open up what was previously a dark mezzanine level.

- At the Sanctuary level, the columns were removed to open up the space and lights were inserted into the bottom of the columns.
- The chandelier, removed from our former church and installed here in 1969, was cleaned and rewired for LED lighting. An electric winch was installed to easily re-position and maintain the chandelier in the future.

- The old plaza was demolished and a new membrane placed to ensure the Plaza no longer leaked.
- The enlarged Plaza over the new Garden Rooms features pavers and a glass wall that overlooks the fountain garden.
- The planters have new trees and plants. Patio benches will be added in the future.
